Review of daylight and sunlight assessment for Brighton Gasworks

Prepared for: Brighton & Hove City Council
Date: 13 January 2022
Report Number: P122214-1000 Issue: 1

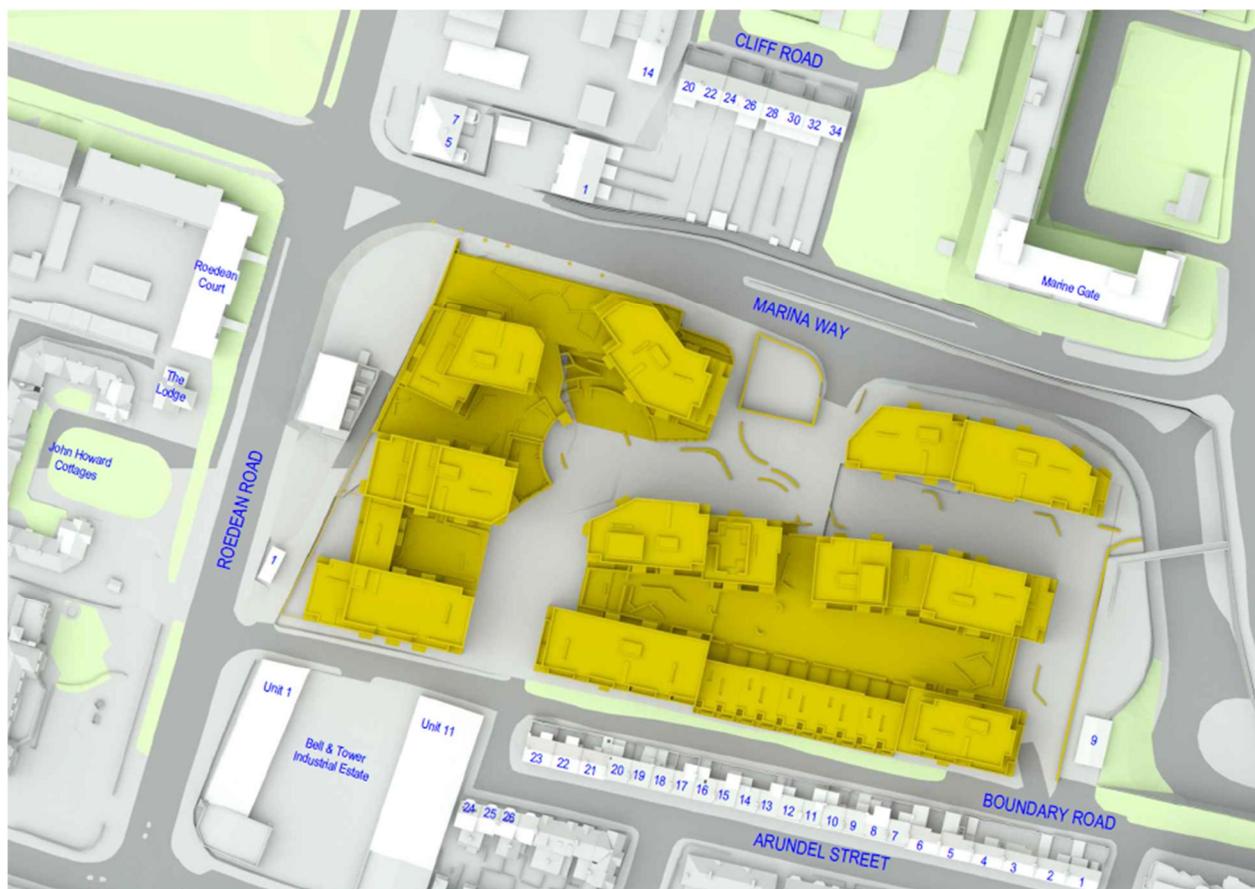
3.1.1 Figure 1 shows the site and surrounding area.

Figure 1: Proposal site (in yellow) and surrounding area. As taken from Appendix 12.1 of the Environmental Statement. North is to the right of the image.

3.1.2 The analysis appears to cover the closest applicable properties to the development and therefore the scope is reasonable, although this was not checked on site.

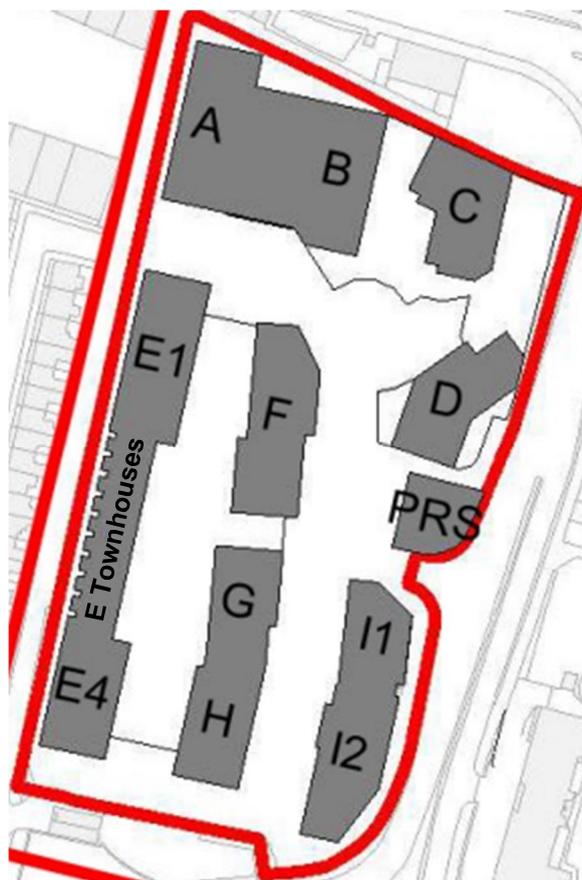
- 4.1.1 Residential accommodation is spread out over a number of proposed blocks. Figure 2 shows the site and location of the blocks.

Figure 2: Proposed site plan. Adapted from drawing by ERP Architects as submitted as part of the application.

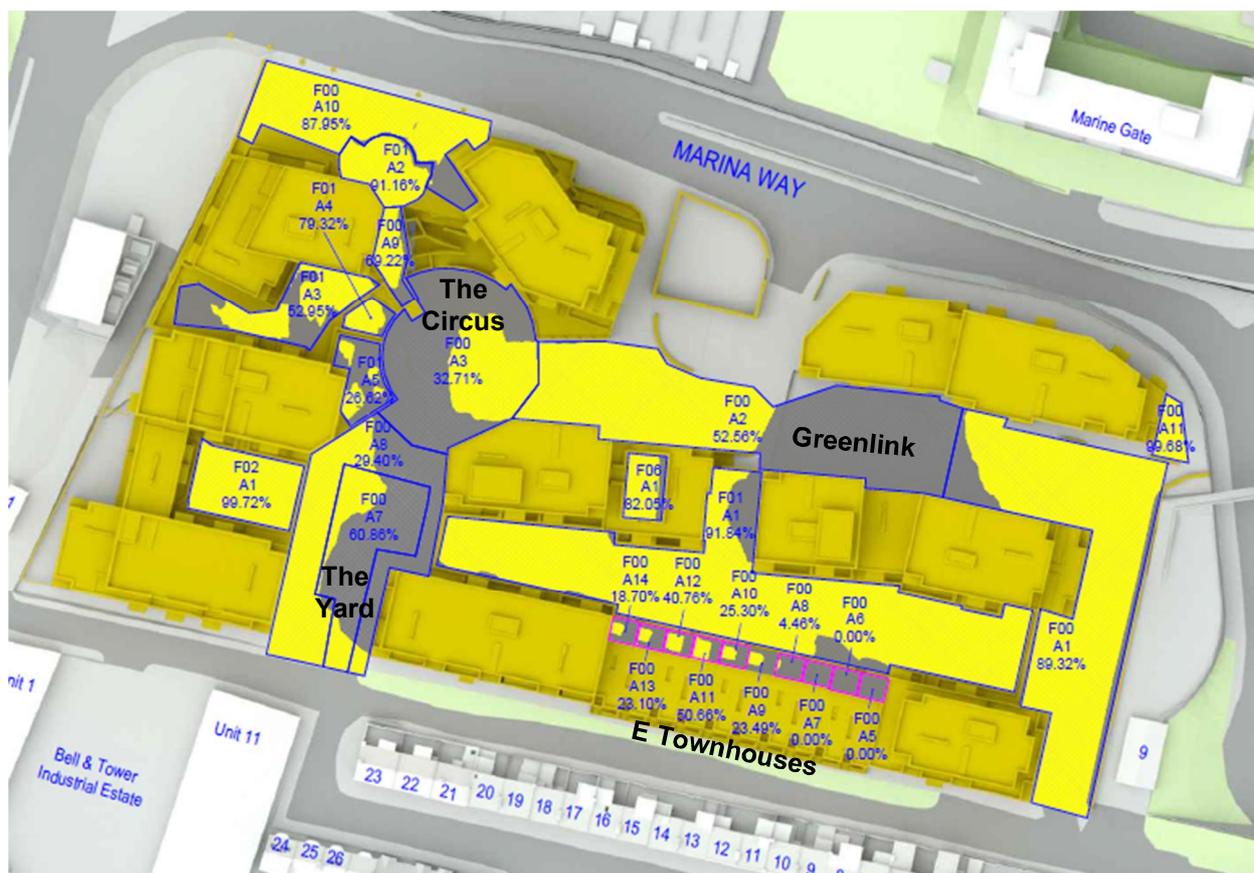
4.4.2 Figure 3, taken from the report, shows the areas able to receive at least two hours of sunlight on 21 March.

Figure 3: Sunlight results for proposed gardens and open spaces. Yellow areas (surrounded by blue or pink lines) show areas able to receive at least two hours of sunlight on 21 March. Grey areas would receive less than two hours. North is to the left of the picture.

- 4.4.3 The area to the east of the townhouses and Blocks E1 and E4 would meet the BRE guidelines and be well sunlit. As would the space to the south of the site.

- 4.4.5 “The Circus” would be below the BRE guidelines and would be classed as inadequately sunlit.
- 4.4.6 “The Yard” has been analysed as two separate areas (the labelled results in the report and Figure 3 above appear to be the wrong way round). The northern area would be well sunlit. The central and southern areas would not be well sunlit. It appears the central area is to be used for vehicular access; sunlight provision here may be less of an issue.

- 4.4.7 Areas to the north of the site generally meet the BRE guidelines, including the courtyard space in Blocks A and B and the area between Blocks B and C (although this is marginal to the guideline). A first floor commercial terrace (labelled as F01 A5 in the report and Figure 3) would be below the guideline.

to A7 in Figure 3) would have none of their area able to receive at least two hours of sunlight on 21 March.
